## PRELIMINARY REPORT

AIC 19 -1002

P2-SET

Air Tractor AT-502B

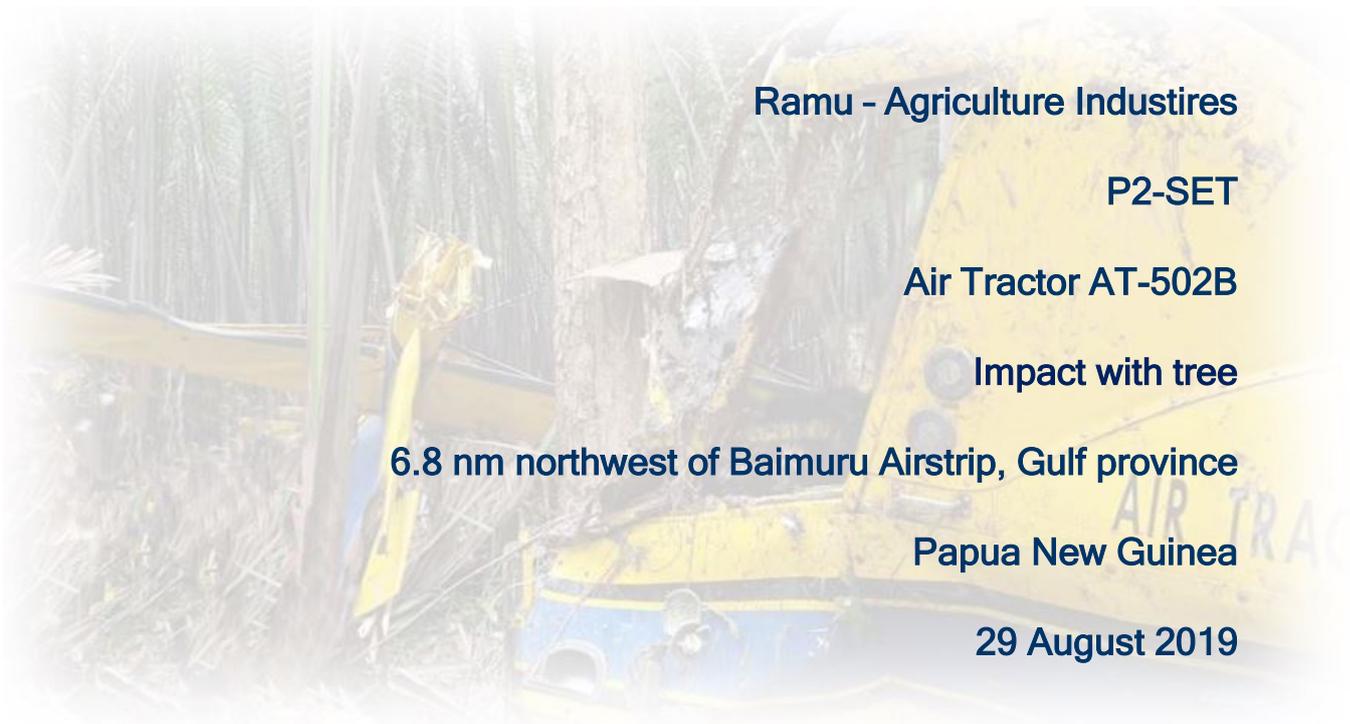
The investigation team found that the outboard section of the aircraft's right wing was torn off as the wing clipped palm trees. The aircraft continued for another 1.3 nm before it impacted a thick tree trunk about 13 metres above ground level. The forward fuselage and engine section separated from the airframe at the bulkhead between the cockpit and the hopper. The forward fuselage including the hopper, main landing gear, engine and propeller continued another 290 metres along the direction of the flight path before becoming deeply embedded in mud. (See figure 1).
