**FINAL REPORT  
AIC 19-1004**

**Air Sanga Limited  
P2-ASZ**

**PAC 750**

**Abnormal airstrip contact during landing**

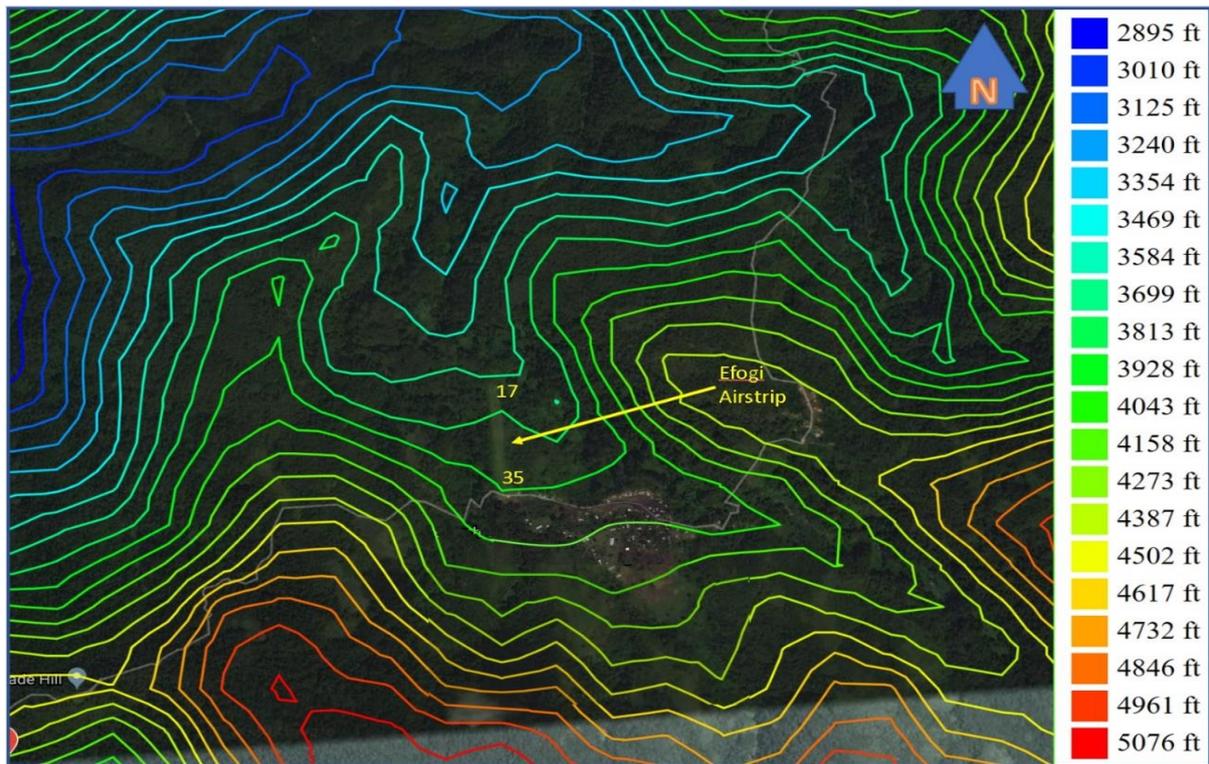
**Figure 9: Efogi Area topography**

As per the topographical data, the Efogi airstrip is situated in a valley with elevated terrain towards the North all the way around to the East which extend up to the Owen Stanley ranges. The ridges extend down towards the South of the airstrip. To the West of the airstrip, the ridges peak at about 5,900 ft. (see Figure 9)

There are about five creeks following Efogi, and there are two rivers which run across immediately to the North and West of the airstrip (approach end) and there is a mountain that extends to the South West. The pilot stated that landing into Efogi, the flight goes between the two rivers and the turbulence experience there is quite strong.

The geographical position of the airstrip and surrounding give the area its own local wind and weather patterns.
