**FINAL REPORT
AIC 22-1001**

On 18 January 2022 at 11:20 local time (01:20 UTC), the AIC was notified by NiuSky Pacific Limited via email of an accident involving a PAC 750XL aircraft, registered P2-BWE, owned and operated by Niugini Aviation Services Limited at Tekin Airstrip, Sandaun Province. The AIC immediately commenced an investigation.

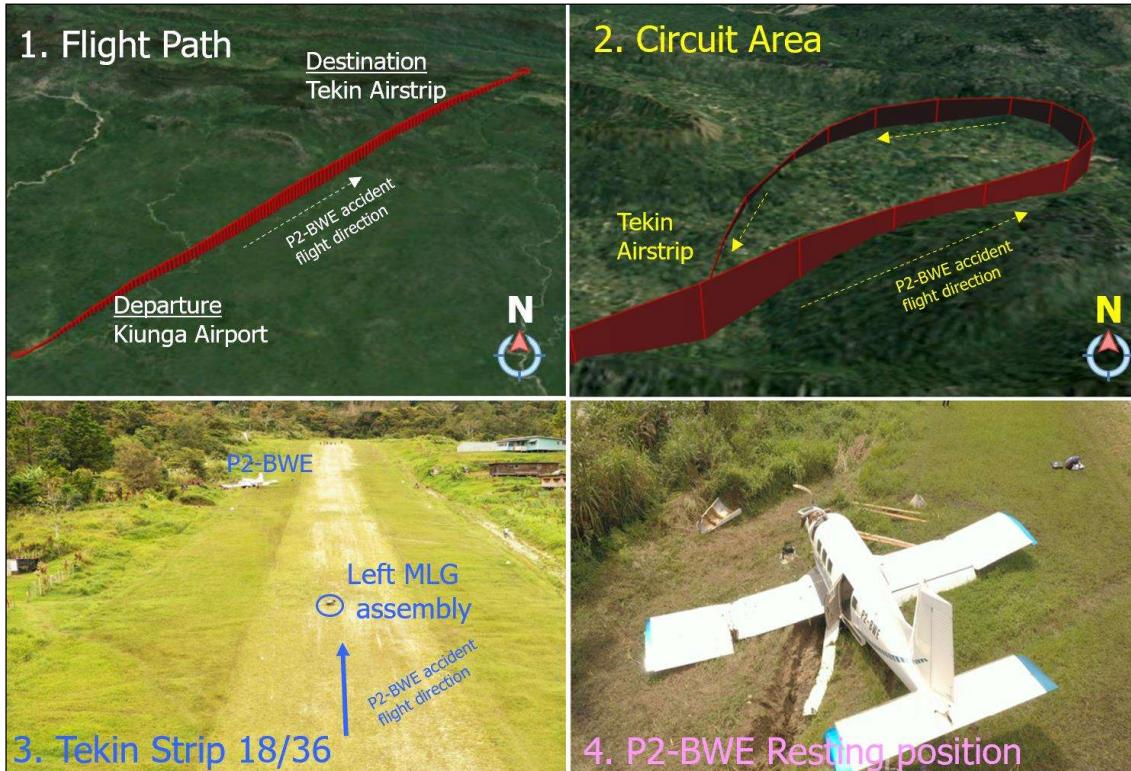
Figure 1: Overview of the accident flight path and the site

On 18 January 2022, at 09:26 local time (23:26 UTC¹), a PAC 750XL aircraft, registered P2-BWE owned and operated by Niugini Aviation Services Limited (NASL), was conducting a single pilot VFR² charter flight from Kiunga Airport, Western Province to Tekin Airstrip, Sandau Province, Papua New Guinea when during the landing roll, the aircraft sustained a left main landing gear (MLG) assembly collapse and subsequent runway excursion.

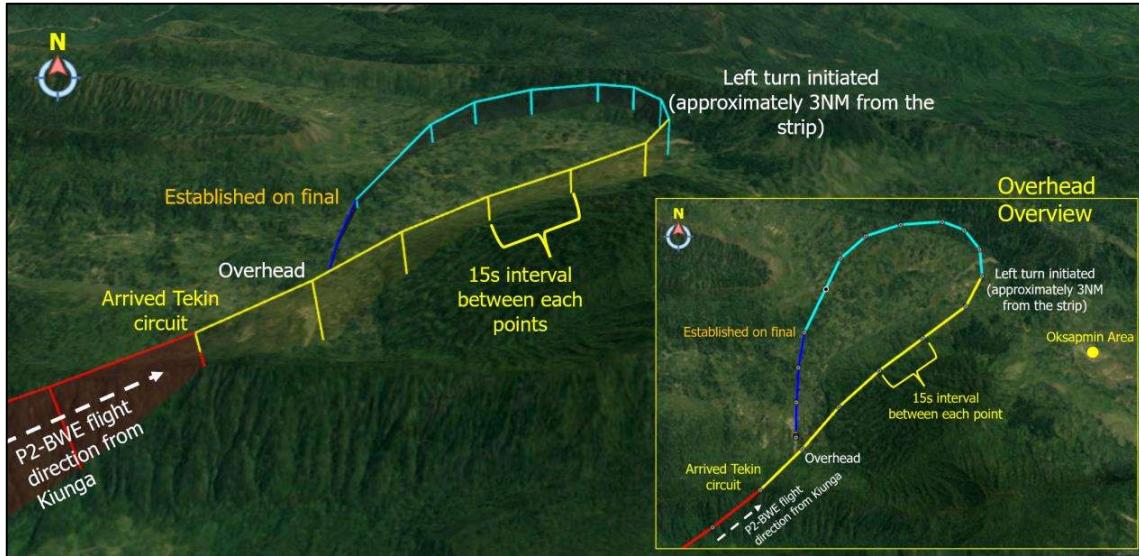
Figure 2: Arrival at Tekin Circuit Area

overhead the field at 2,800 ft AGL⁵. The aircraft then tracked towards the northeast of the airstrip. At about 3 nautical miles (NM) Northeast of the airstrip, the pilot turned left base for approach. The aircraft established on final approach profile about 1 NM from the airstrip runway 18 designated landing threshold at a height of about 500 ft AGL. The pilot stated during interview that while positioned overhead, he conducted an aerial inspection and from his observation, the airstrip appeared suitable for landing.

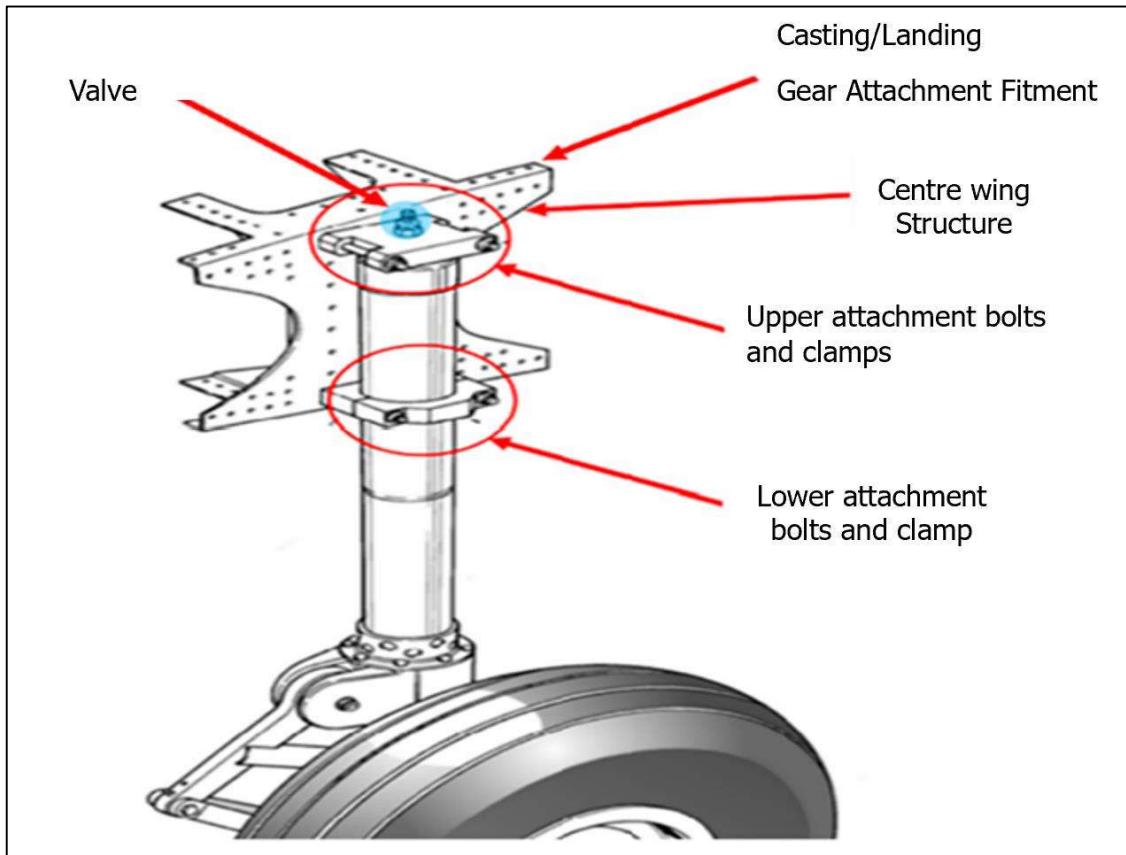
Figure 3: MLG Assembly

1.6.7 Main Landing Gear System

The maintenance records also shows that the left MLG had defects which was recurring as detailed in the table below.

- tire assembly was intact with no damage
- Strut oleo with the allowable amount of fluid and pressure with valve core cap intact
- Torque link was intact and had castellated nut with safety split pin missing
- Brake assembly unit was intact with hose supplying fluid snapped off from the top; and
- Both strut upper attachment bolts sheared off at the head side

The MLG was disassembled by AIC and observed that all internal and external parts of the MLG strut assembly were intact including O ring had no visible damage. There was also no evidence of fluid leakage.

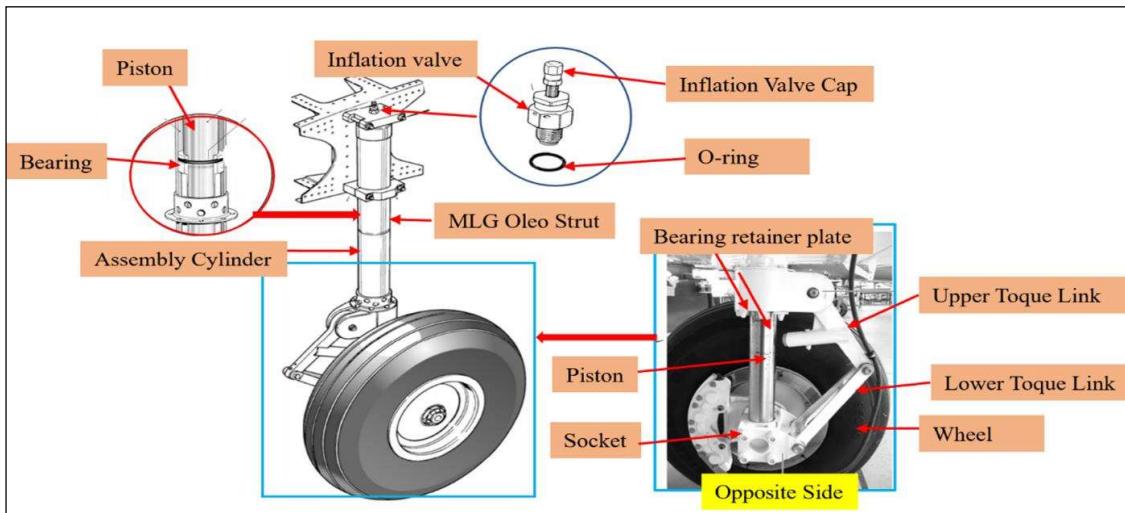
Figure 4: MLG Oleo Strut

Shock strut is assembled with a piston and a bearing, and it is divided into two chambers by an orifice plate that allows the hydraulic fluid to travel between the lower and upper chambers. The lower part of the strut is filled with hydraulic fluid and the remaining space in the upper part of the strut is filled with nitrogen. The movement of this fluid through the orifice by the piston movement during landing and taking off reduces force and vibrations to the aircraft.

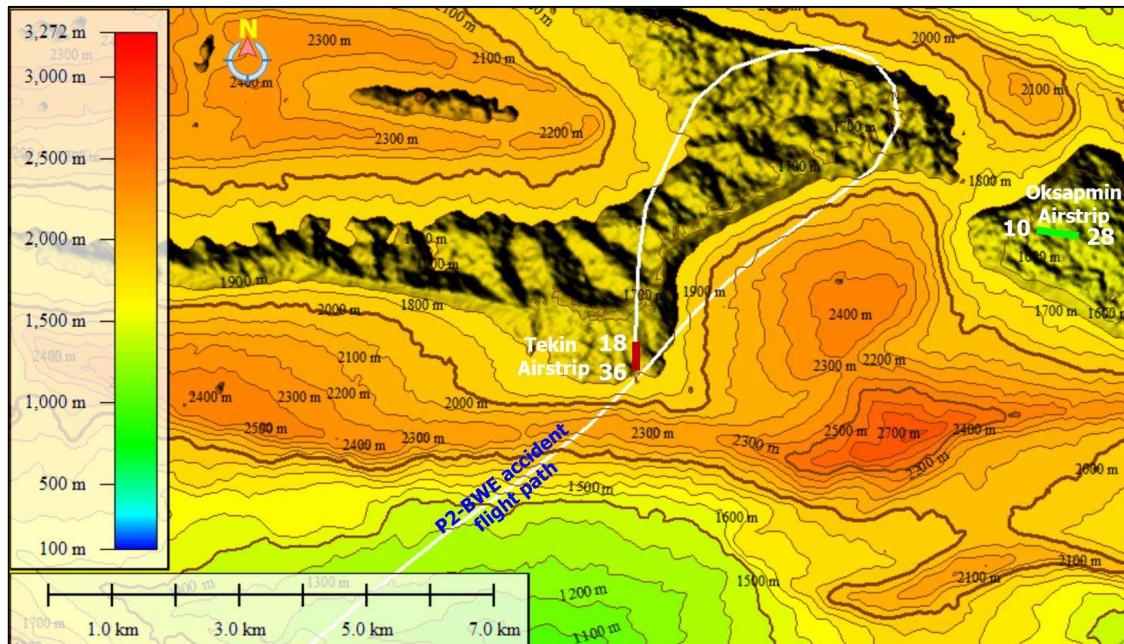
Figure 5: Tekin Area Topography

As per the topography data, Tekin Airstrip is located in a valley surrounded with mountain ranges and is situated at the foot of Mt. Wamtakin. The mountain is 1,800m (about 5,900 ft) high and has a long ridge extending in an East-West direction and is located to the south of the airstrip. There is a river also located in the valley, to the North of the airstrip, and runs in an East-West direction as well.

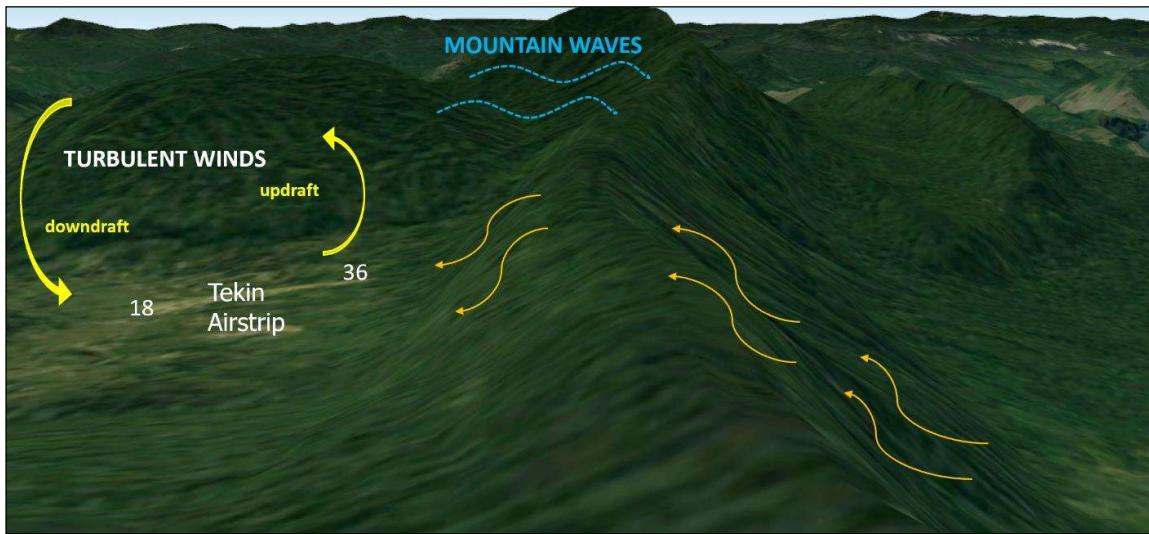
Figure 6: Localise wind pattern at Tekin Airstrip

The geographical position of the airstrip and surrounding give the area its own local wind and weather patterns

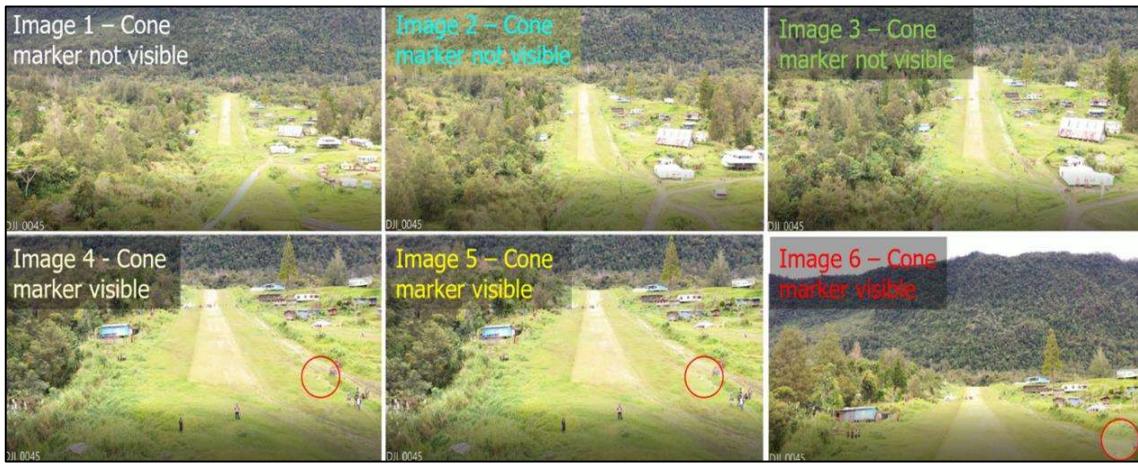
Figure 8: Airstrip image taken by the drone flown along the approach path

There were two cone markers to the right of runway 18 about 5m up the runway from the edge of the runway. Their purpose was to indicate the designated landing threshold of the runway where the surface is levelled, however it was observed that the cone markers were not in good condition to be clearly visible. The runway surface shows evidence of a normal touchdown point 20-30m up the runway of the designated landing threshold.

During the on-site investigation, it was established that the aircraft's initial touchdown was about 2m short of the designated landing threshold indicated by cone markers and the MLG collapsed subsequently. The investigation also established that 15m from the initial touchdown point, the aircraft's left-wing assembly dropped, hit the ground and the flap detached and began to drag on the surface creating markings. About 40m after the initial touchdown, the left MLG assembly⁹ was found on the runway surface.

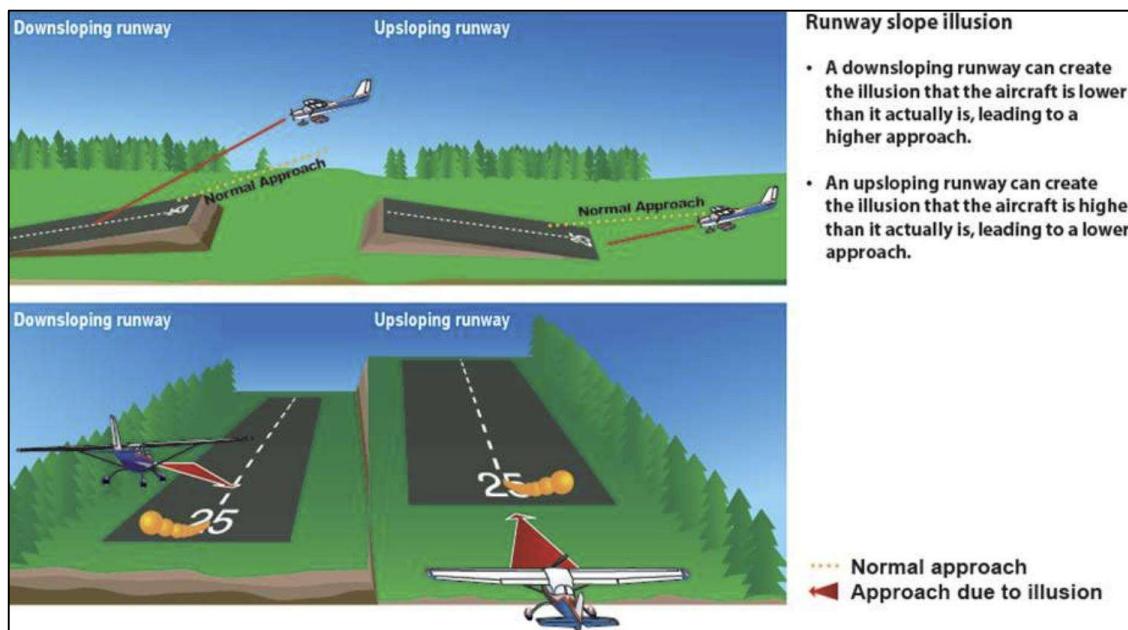
Figure 18: Upslope and downslope visual illusion (Source: FAA PHAK,17-7)

An upsloping runway, upsloping terrain, or both can create an illusion that the aircraft is at a higher altitude than it actually is. The pilot who does not recognize this illusion will fly a lower approach. Downsloping runways and downsloping approach terrain can have the opposite effect.

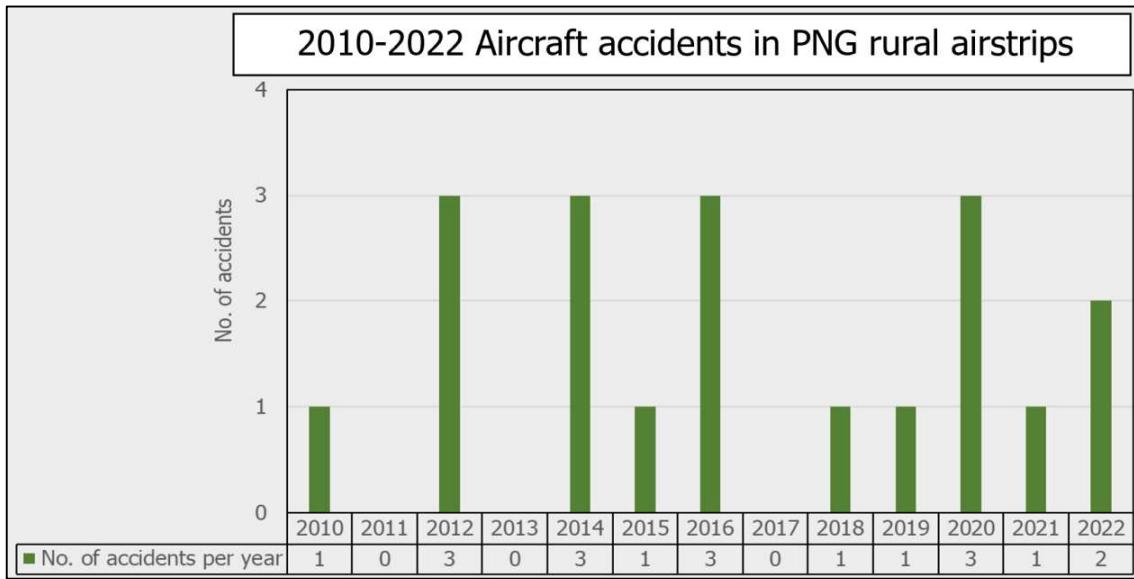
Figure 19: Rural Airstrip accidents per year

The AIC found that with an average of about two accidents per year has been a aviation safety concern for the travelling public into rural airstrips.
