**PRELIMINARY REPORT**

**AIC 24-1003**

**P2-SAM**

**Aircraft Impact with Terrain**

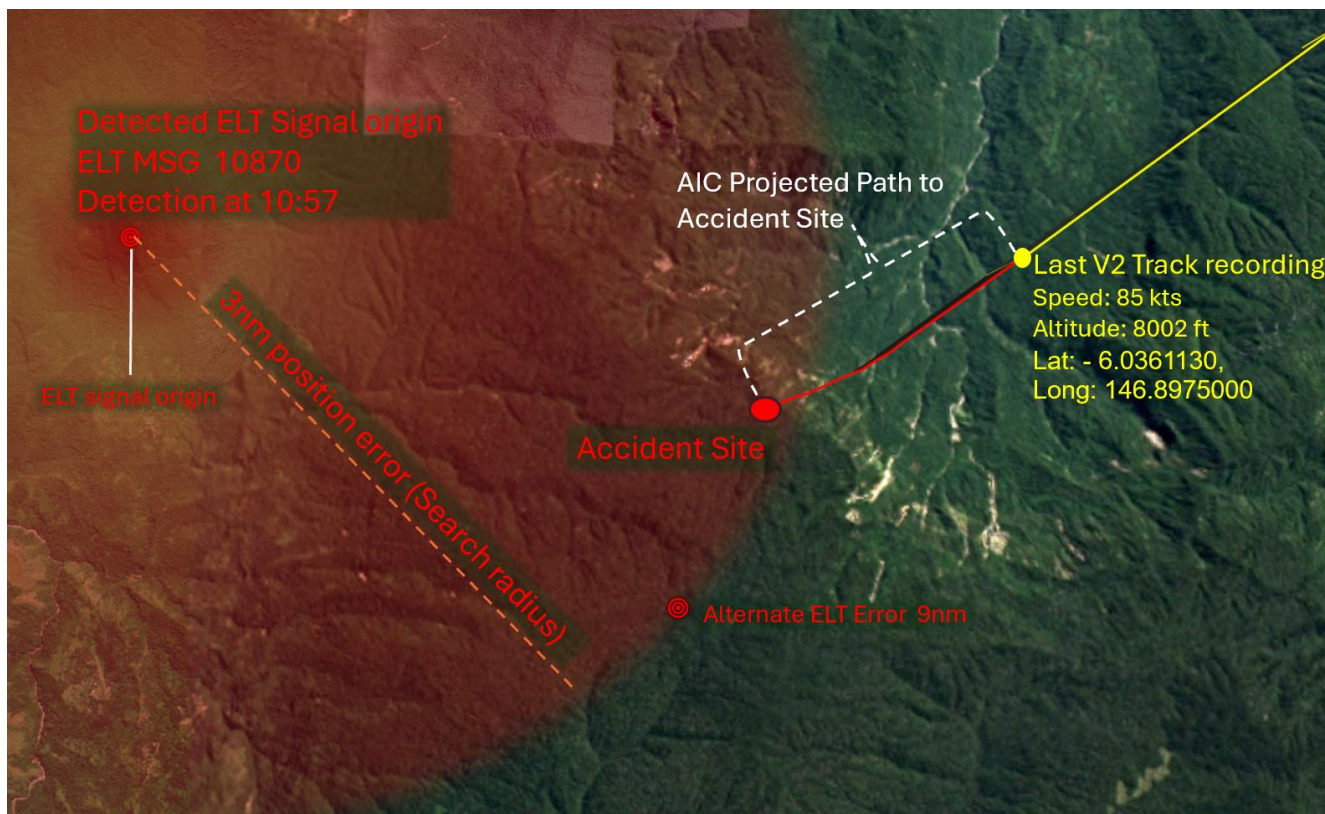
According to the Operator’s V2-Tracking System, at about 10:21, the aircraft took a left heading from the coast and began tracking Southwest while continuing the climb through 5,500 ft<sup>7</sup>. This track was maintained until the last recorded position at 10:26:59. The last recorded point showed that the aircraft was 5.7 NM Northeast of Sapmanga, at 85 kts<sup>8</sup>, and at an altitude of 8,002 ft. The wreckage position coordinates showed that the last recorded flight position was about 1.8 NM Northeast of the accident site.
