FINAL REPORT

AIC 24-2001

P2-BBM

Runway Excursion During Landing

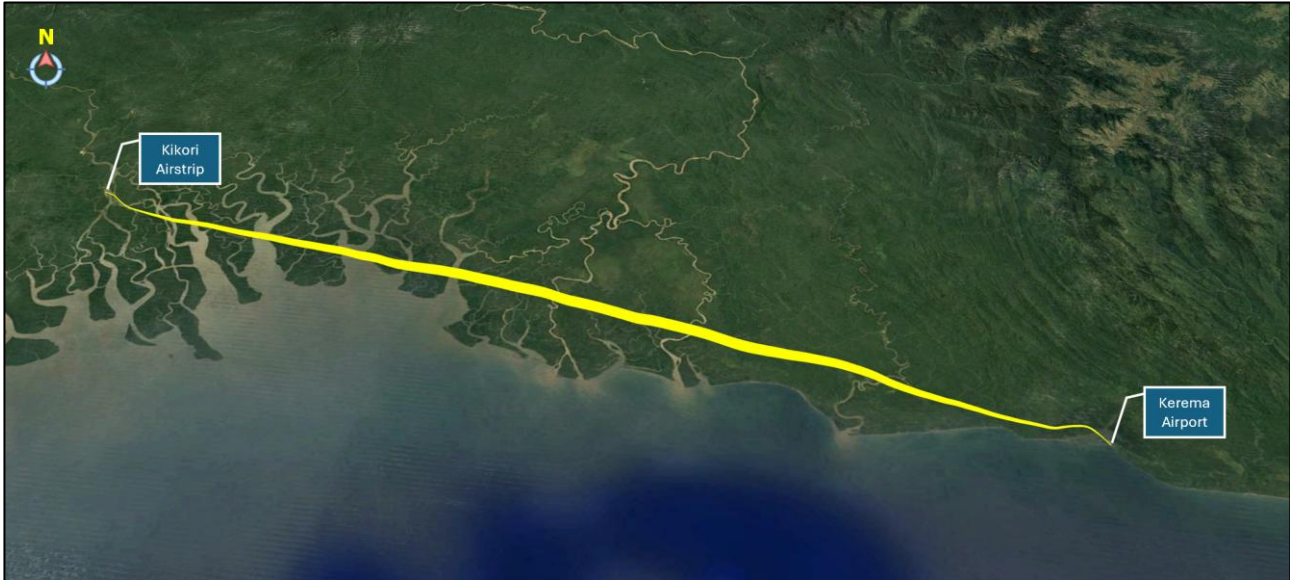
Figure 2. Depiction of P2-BBM flight path.

The recorded data³ showed that P2-BBM departed Kerema Airport at 11:04 and commenced a climb to an altitude of 8,000 ft AMSL and began tracking Northwest to Kikori Airstrip with an estimated arrival time of 11:45 (Refer Figure 2).

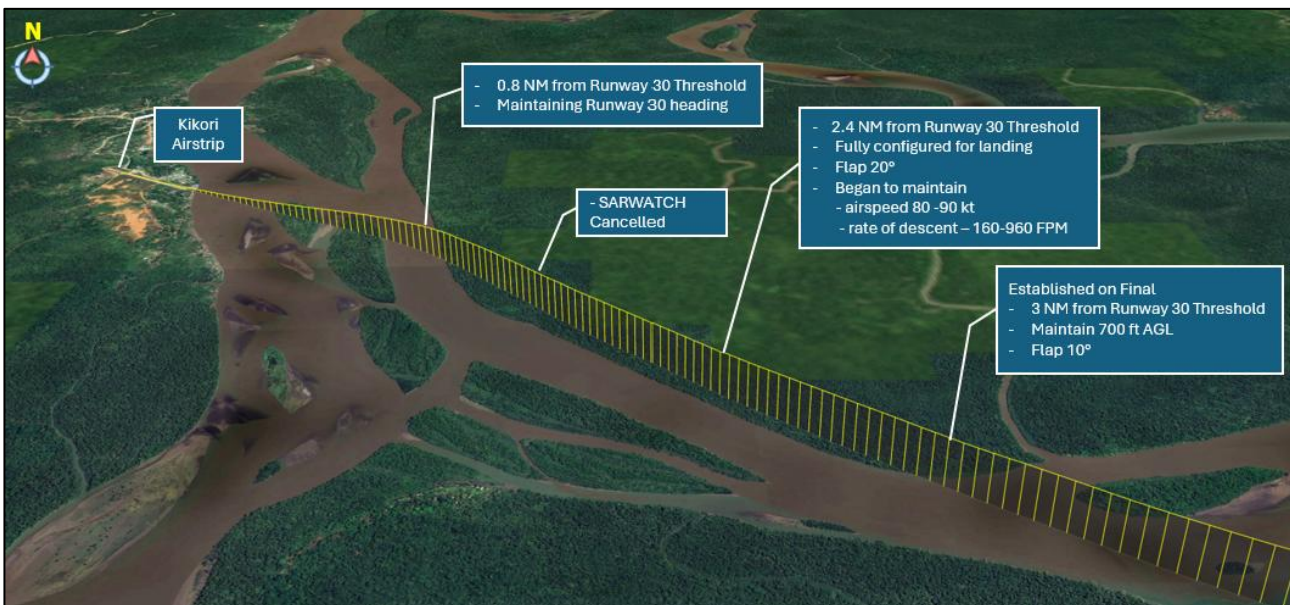
Figure 3. Recorded data showing where P2-BBM was established on final approach for Runway 30.

According to the Air Traffic Services (ATS) recording, at 11:42:14, the crew cancelled SARWATCH. At 11:42:55, the recorded data indicated that the aircraft was 0.8 NM from RWY 30 threshold. The aircraft maintained the runway heading while gradually reducing height and speed, and touched down at 11:43:27 with an airspeed of 73 kts and a groundspeed of 86 kts.

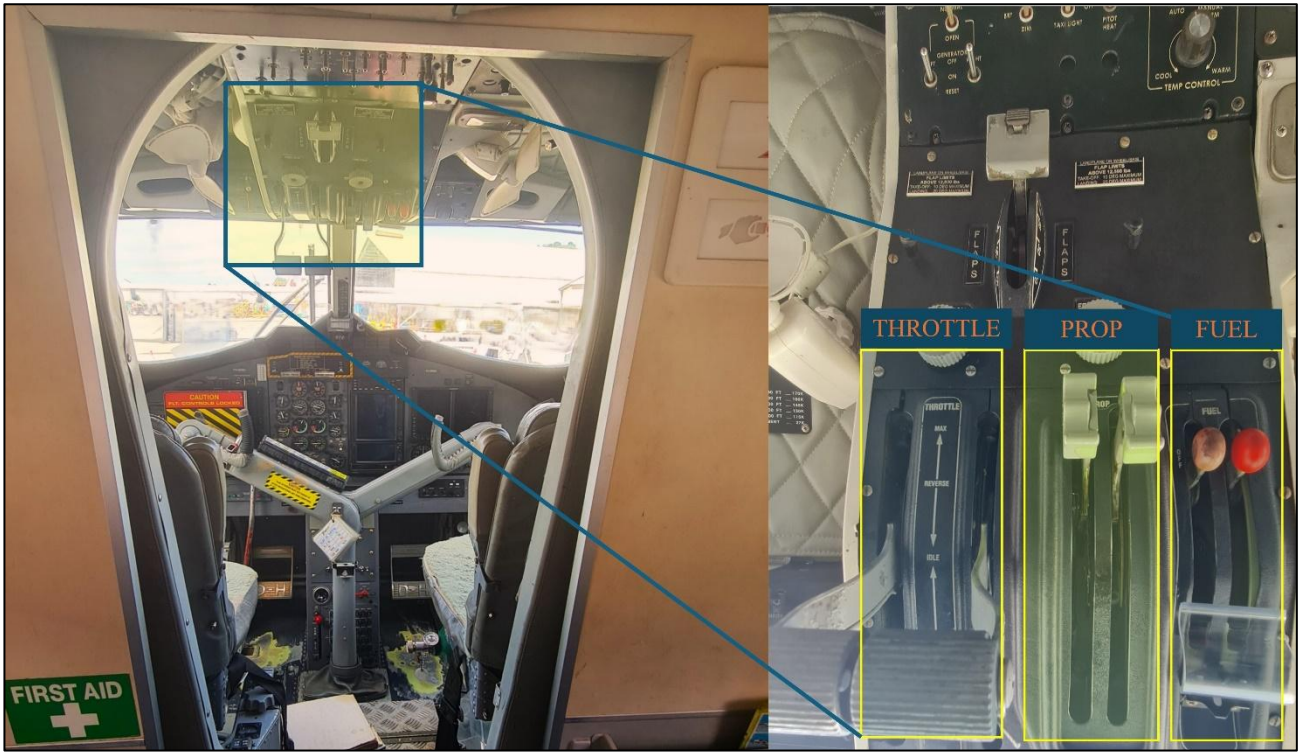
Figure 5. P2-BBM Power Quadrant.

Control of an engine is achieved through the operation of the power lever control system, the fuel shut control and the propeller control system. The control levers for each system are mounted in the flight compartment overhead console.

A cable attached to each lever quadrant runs along the aircraft roof, wing leading edge, and engine nacelle to its respective control pulley on the engine firewall. From the control pulleys, a rod or Teleflex is used to actuate the fuel control unit (FCU), fuel shut-off valve and the propeller governor. Both engines are controlled by identical systems.

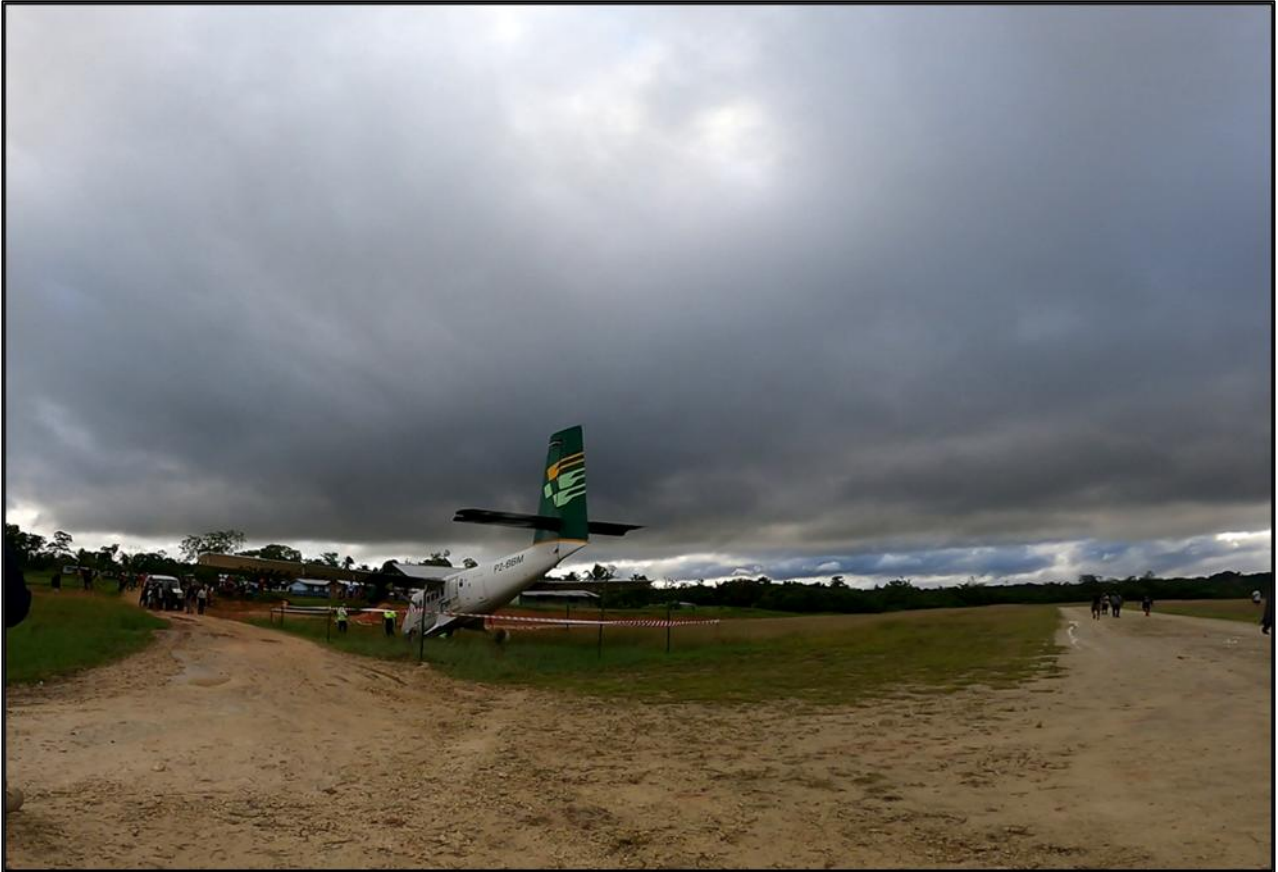
Figure 6. Photo taken on the day of occurrence by onsite investigation team (4:40 pm local, 8 Jun 2024).

Prior to departure from Kerema Airport, the crew received weather information for Kikori Airstrip from the local agent. The agent reported that it had rained throughout the week, however there was no rain at that time, and the weather was fine.

On arrival in the Kikori area, the crew observed light clouds and no rain over the airstrip, and no wind. They added that even though the approach began in cloud, they could see the river below along the approach path, and got visual 4 NM from RWY 30, at a height of about 800 ft AGL.

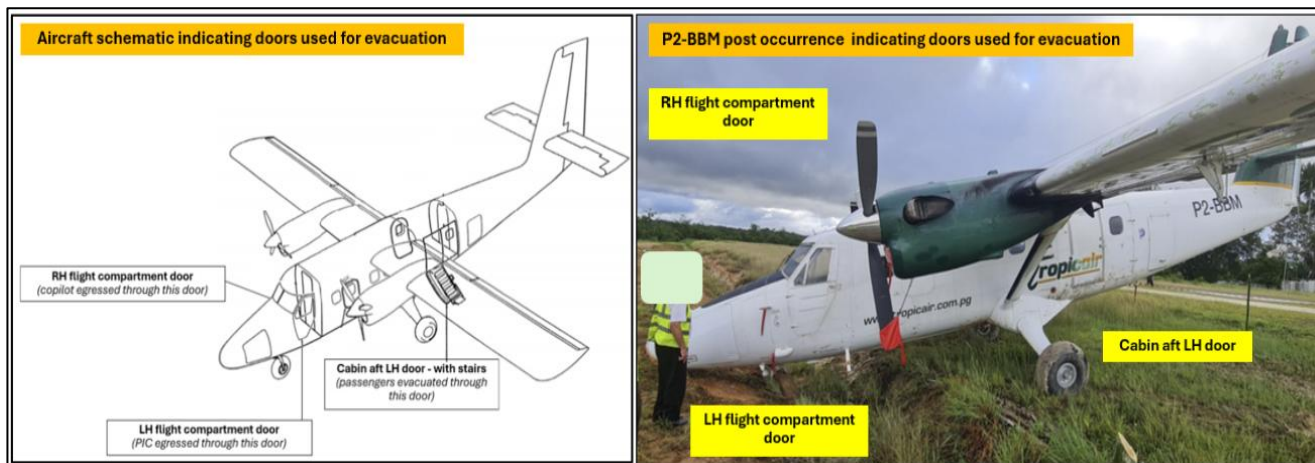
Figure 15. Aircraft schematic and P2-BBM post occurrence indicating doors used for evacuation.

The co-pilot reported that once the aircraft had come to a complete stop and the engines were shut down by the PIC, following the occurrence at Kikori, he opened the right hand (RH) flight compartment door and egressed the aircraft. He then went around to the rear left side of the aircraft and opened the cabin aft left hand (LH) door of the aircraft, from the outside, and deployed the stairs to facilitate passenger evacuation. He observed that the passengers appeared shaken and were reluctant to leave the aircraft. Subsequently, he encouraged them to exit, and they egressed the aircraft.

The co-pilot confirmed that the passengers egressed the aircraft through the cabin aft LH door while the PIC egressed the aircraft through the LH flight compartment door. The passengers were then relocated to a safe area away from the aircraft.
