**PRELIMINARY REPORT**

**AIC 25 - 1001**

**P2-AXL**

**Runway Excursion During Landing**

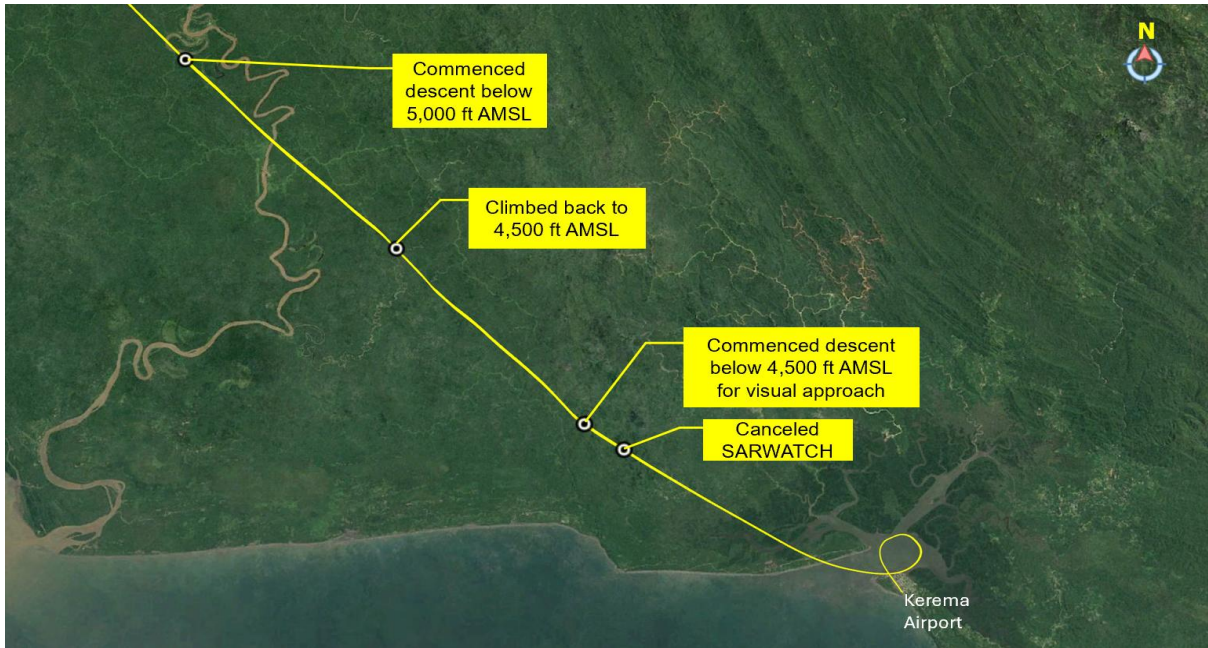
**Figure 2: P2-AXL flight path after descending below 5,000 ft**

The crew then tracked east over the airfield, joining a left downwind before turning left onto the base leg for Runway (RWY) 14 while passing through 700 ft AGL. At 10:27, the aircraft was established on final approach, passing through 150 ft AGL.

According to the crew, while turning onto final, they observed a tailwind from the right. The PIC added that as the aircraft descended closer to the runway surface, the effect of the tailwind from the right decreased and maintained about 10 Knots (Kts), which is below the maximum allowable tailwind component for the aircraft and therefore, the crew proceeded with the landing.

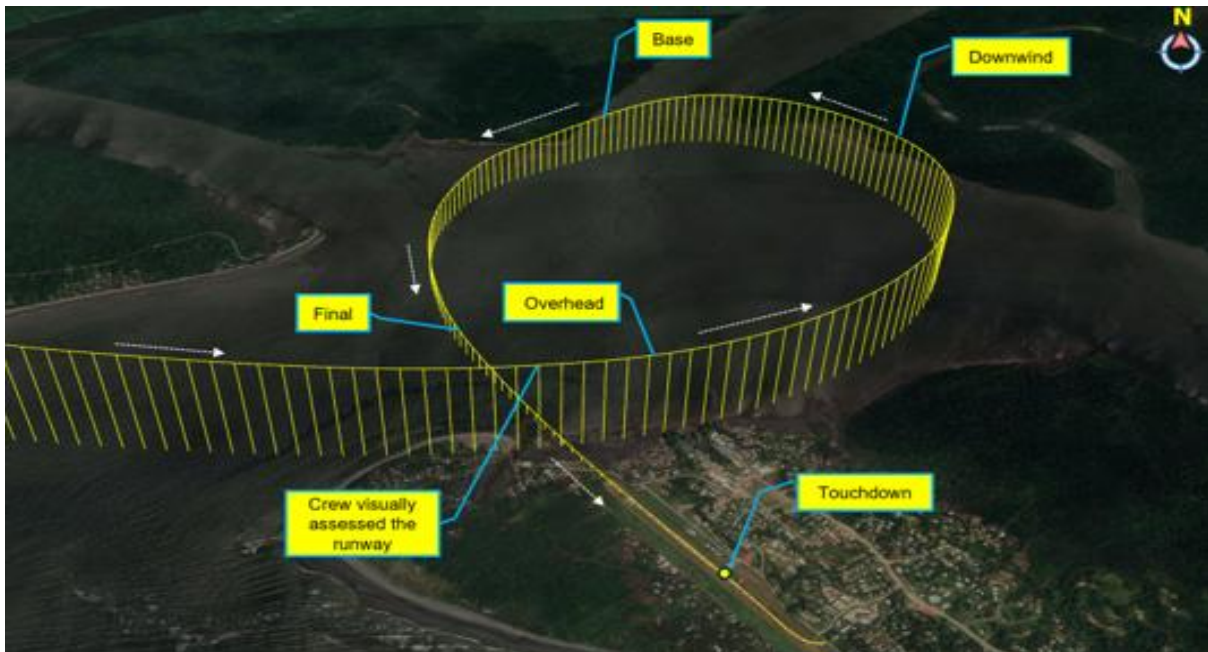
**Figure 3: Kerema Airport Circuit Area**

The recorded data also indicated that there were no abnormalities with directional controllability on touchdown as well as the initial landing roll. The aircraft continued to decelerate while tracking along the runway centerline after touchdown. However, according to the PIC, when he attempted to apply the brakes to further reduce the aircraft's speed, it began to gradually drift to the right of the centerline.
