FINAL REPORT

AIC 25-1002

18 MAY 2026

CONTRACTOR	:	Liddles Aerial Spraying Pty Ltd
OPERATOR	:	Ramu Agri Industries Limited
REGISTRATION	:	VH-SOY
MANUFACTURER	:	Cessna Aircraft Company
MODEL	:	T188C
CLASS/CATEGORY	:	Ground Impact During Low Altitude Operations (LALT)
LOCATION	:	Sangkiang Village, Ramu, Madang Province
OCCURRENCE DATE	:	23 April 2025

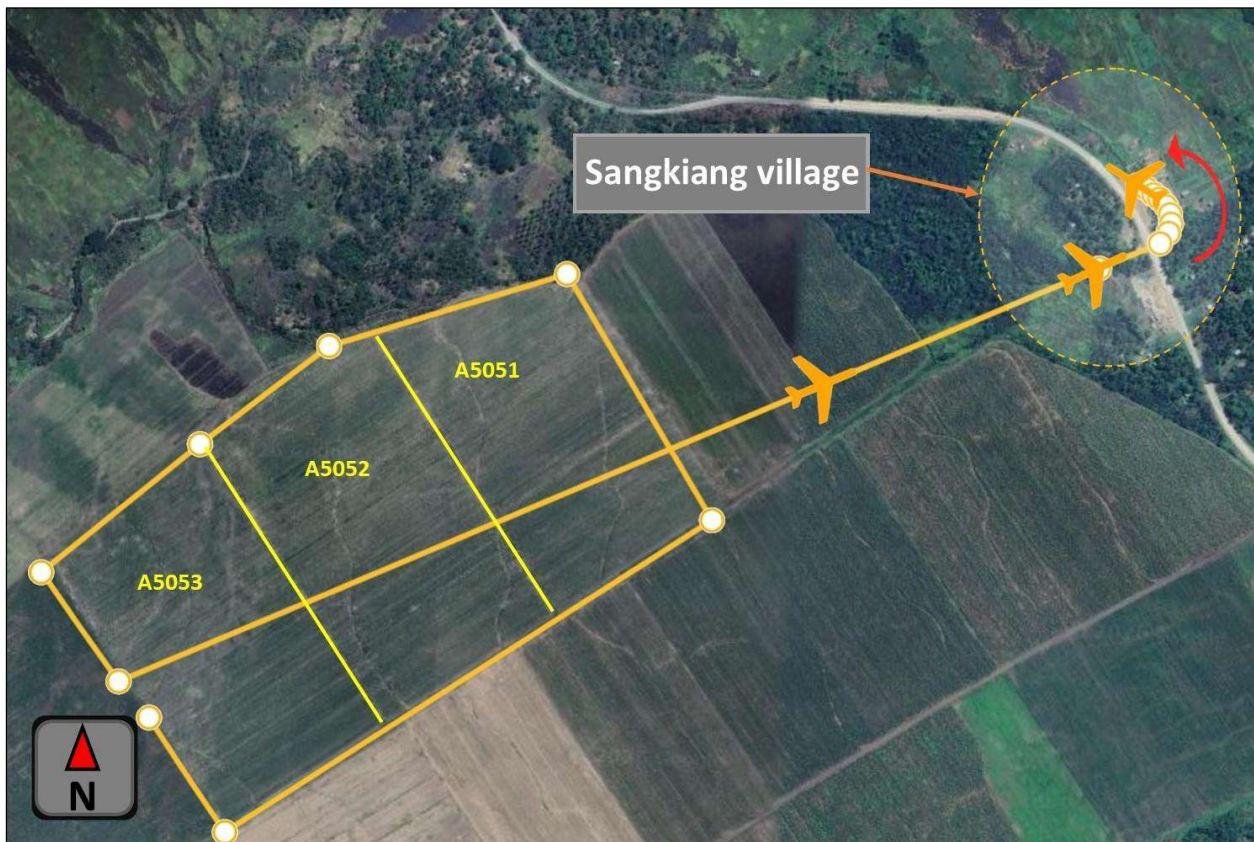
Figure 2. Depiction of flight track from sugarcane fields to accident site.

The aircraft had tracked northeast from the sugarcane fields towards Sangkiang Village. Witnesses reported that as the aircraft approached Sangkiang Village, they estimated the aircraft’s height to be approximately 20 to 30 metres higher than the coconut tree canopy while dispensing chemicals.

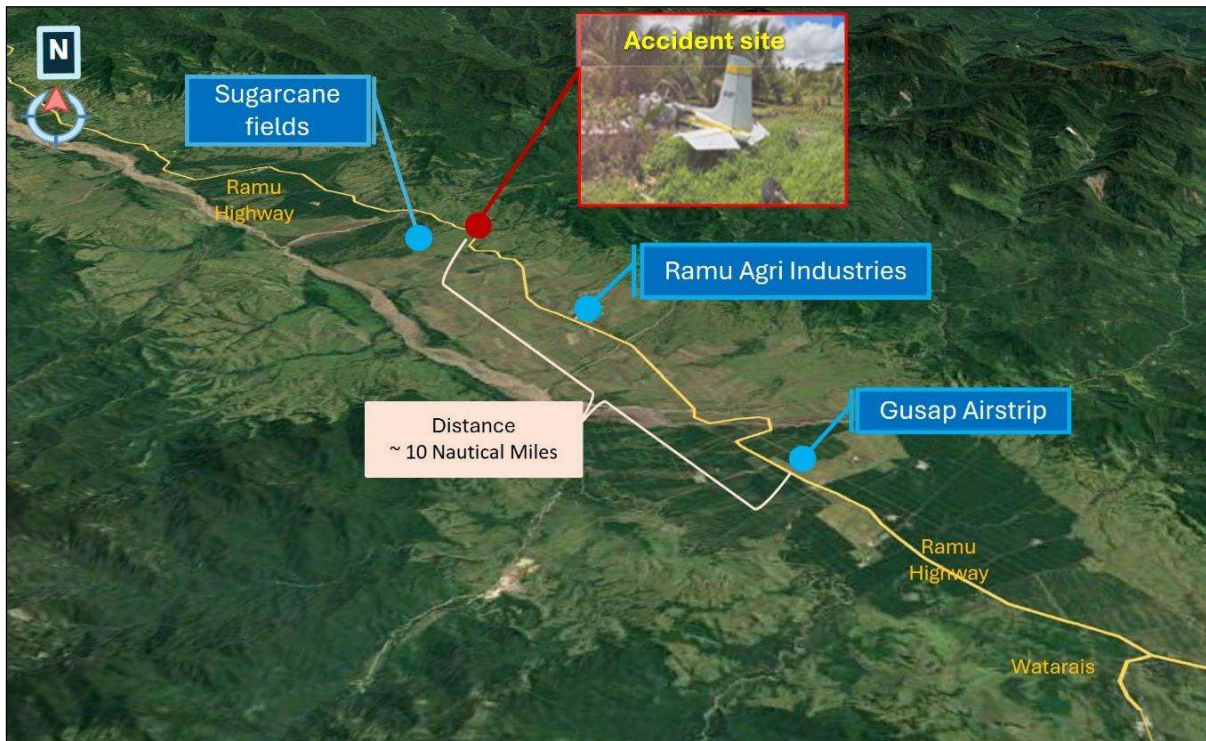
Figure 3. Overview of Accident site, Gusap Airstrip and surrounding sugar fields.

Witnesses also reported observing the aircraft entering a descending left turn after it crossed the highway. During the descending left turn, the aircraft clipped the tops of trees before impacting the ground adjacent to the highway. The aircraft skidded forward for approximately 5 metres while simultaneously yawing to the right, ultimately coming to rest with its nose oriented toward the northeast.

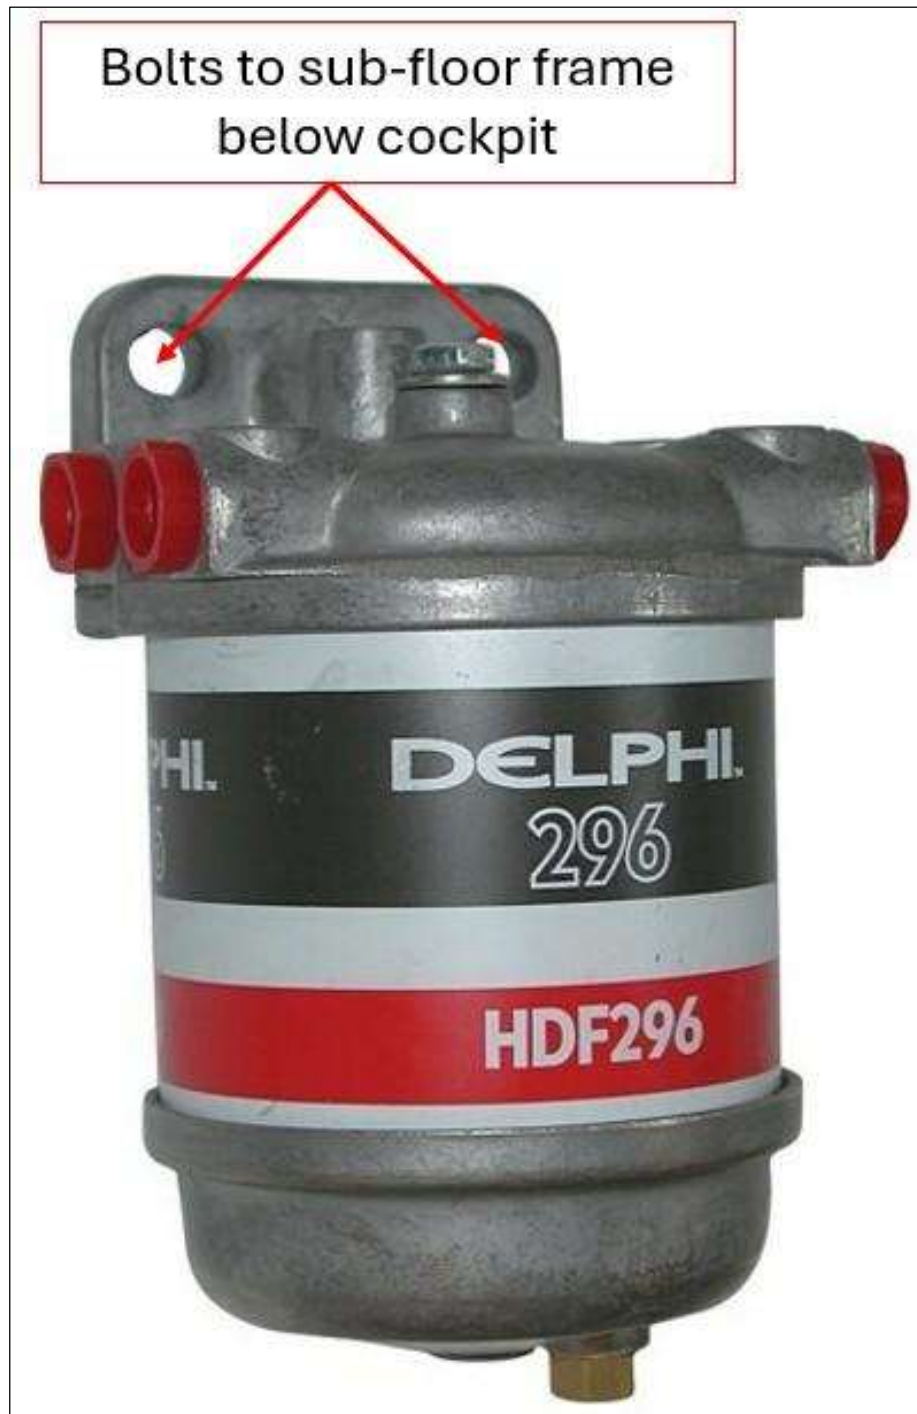
Appendix 5.2 Fuel filter assembly

Delphi 7111-296 fuel filter assembly
