OFFICE OF THE CHIEF COMMISSIONER

Safety recommendation: AIC 19-R22/18-1002

Addressed to: Air Vanuatu (Operations) Limited

Investigation link: AIC 18-1002

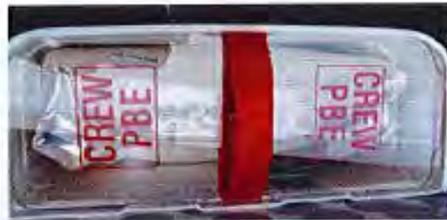
F7.02_P8A: PBE stowage box

The PBE is a device that completely encloses the head of the wearer and seals around the neck with an elastic membrane. The unit is vacuum sealed in a bag and installed in a protective stowage box within the aeroplane cabin.

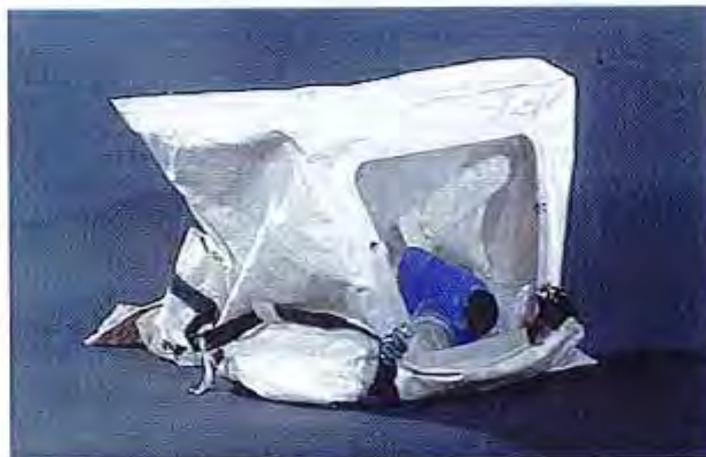
F7.02_P8B: PBE deployed

The PBE can be worn with spectacles (eyeglasses).
